INVESTIGATION OF A DEPLOYABLE POLYURETHANE FOAM GROUND  
IMPACT ATTENUATION SYSTEM FOR AEROSPACE VEHICLES

Volume II. FIAS Test No, 49-91

TECHNICAL REPORT AFFDL-TR-78-145, VOLUME II

AIR FORCE FLIGHT DYNAMICS LABORATORY  
AIR FORCE WRIGHT AERONAUTICAL LABORATORIES  
AIR FORCE SYSTEMS COMMAND  
WRIGHT-PATTERSON AIR FORCE BASE, OHIO 45433

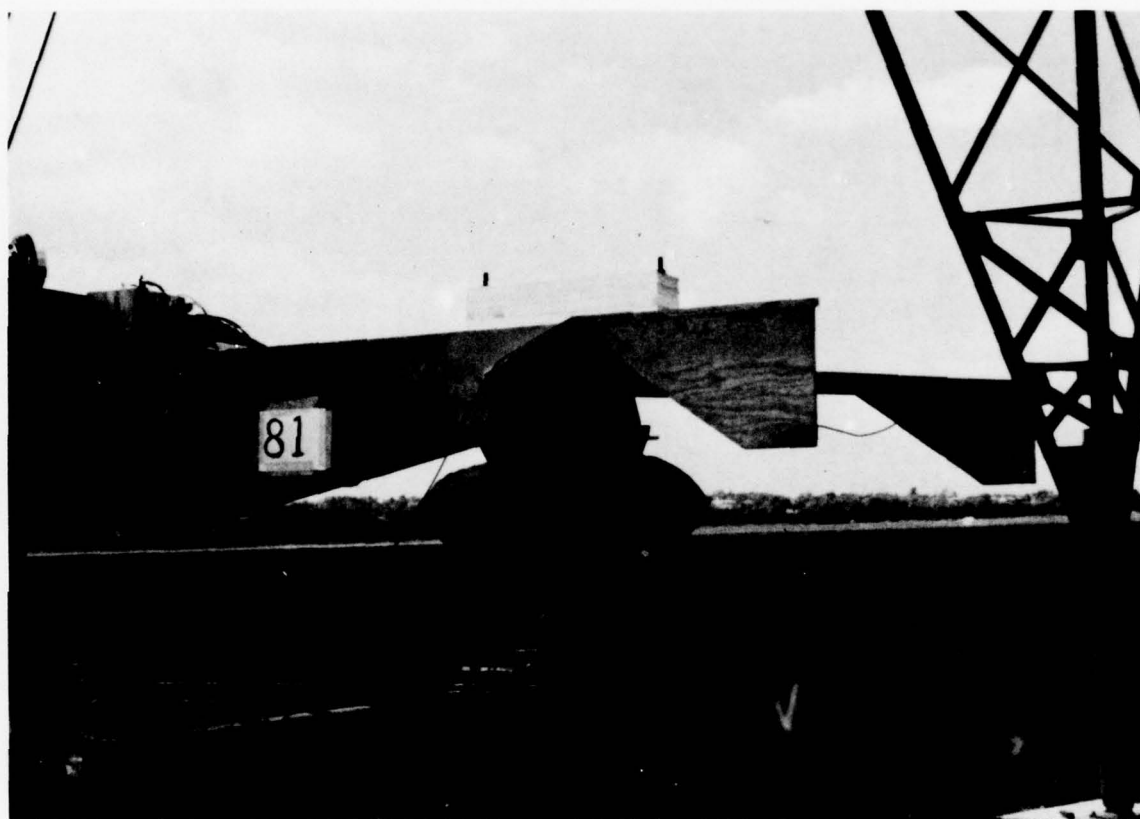
Figure 19. Short Tail Bag, Pre-Test

Because the center of the main FIAS bags was at F.S. 55 while the vehicle center of gravity lie between F.S. 78 and F.S. 80, a tail pitch down was expected. Accordingly a tail bag was designed to accommodate this pitch axis rotational energy. The tail bag arrangement used from Tests No. 65 through 84 was an oblate spheroid 15 inches thick by 30 inches in diameter. Starting with Test No. 85 and going through Test No. 91 this geometry was changed to that of a cylinder 16 inches in diameter by 26 inches in height. These two bags are shown in Figures 18 and 19. These tail bags were prefoamed and bolted onto the test vehicle prior to test. The short tail bag (15 inches) performed adequately in conjunction with the Mark VIII FIAS main bag as shown in Figure 20 where the frangible horizontal stabilizer endplate has been broken. The tail bag height was increased to 26 inches for Test No. 85 in conjunction with the taller Mark IX FIAS main bag in an attempt to provide more clearance for the pods. At the oblique yaw angles, however, this taller bag tended to roll out from under the vehicle as shown in Figure 21 after Test No. 86.

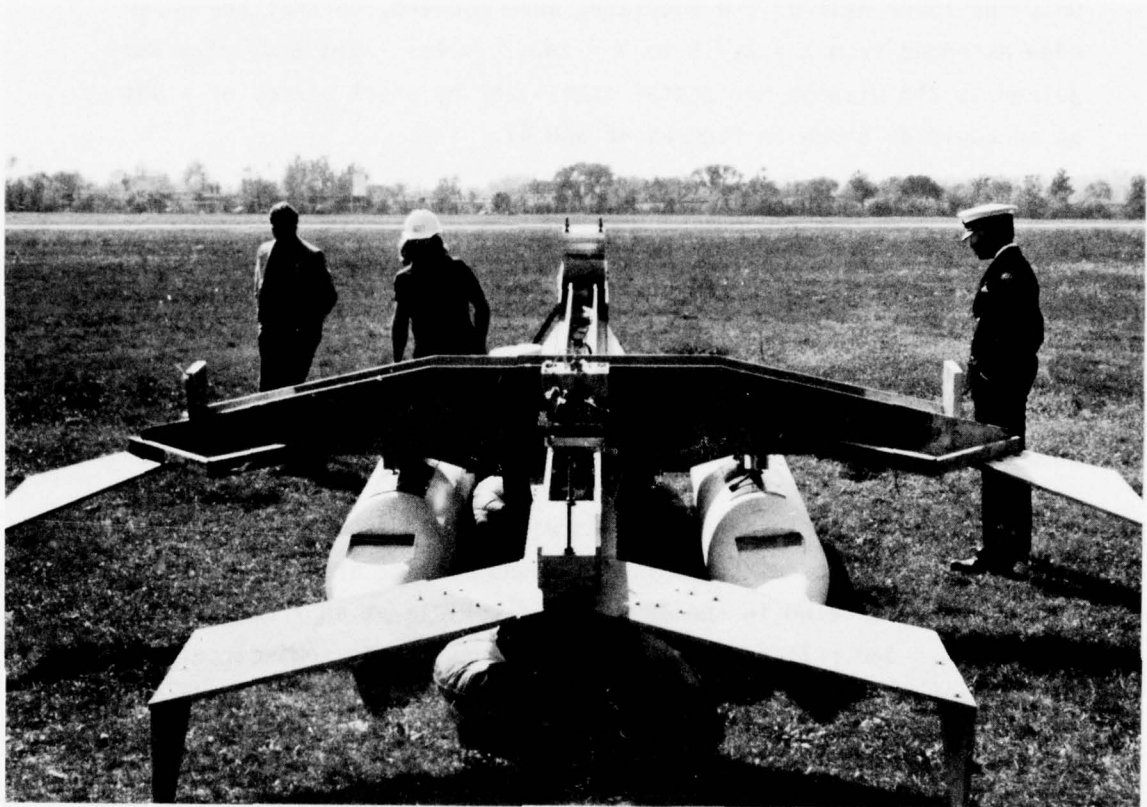
Figure 46. Horizontal Stabilizer (Test No. 84)

d. The frangible horizontal stabilizer endplates were located at a Y coordinate of  $\pm 44.5$  inches with the first contact edge at  $Z = 7.5$  inches. Only the lower half of the endplates were modeled, so that the upper edge extended from  $X = 217.5$  to  $X = 243.2$  inches. The endplates were joined to the plywood horizontal stabilizer by short pieces of aluminum at an angle as shown in Figures 46 and 47.

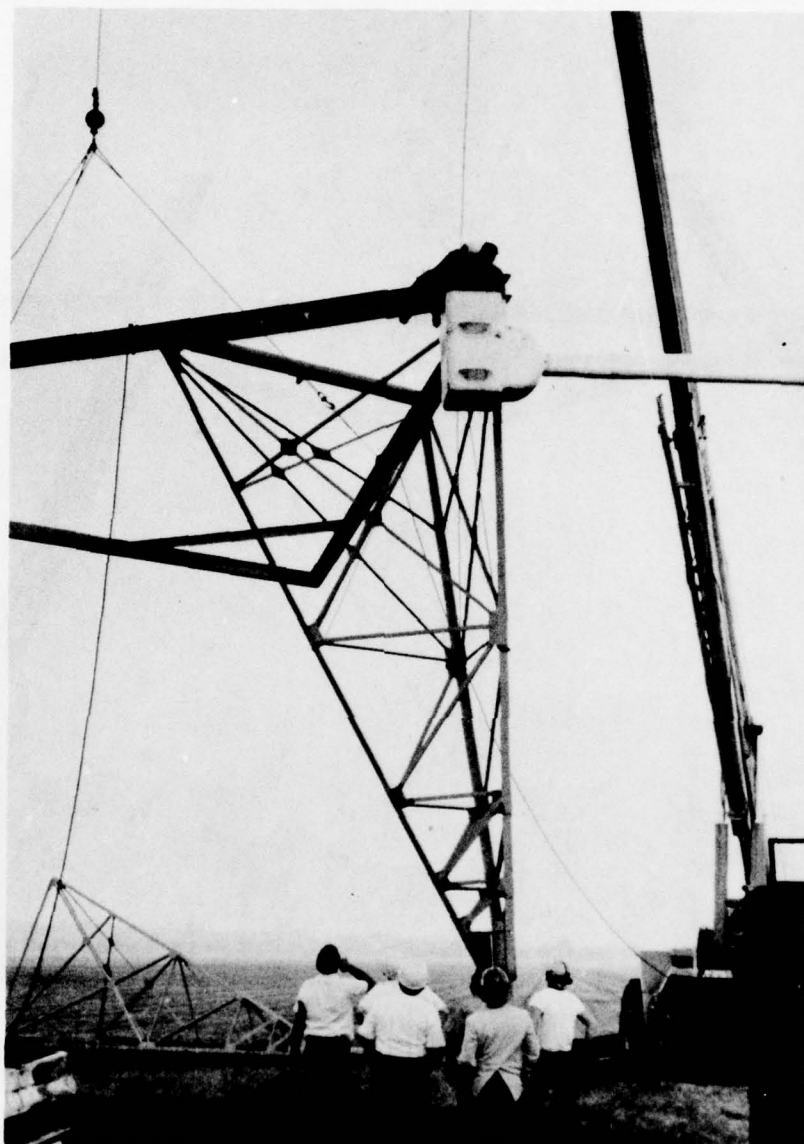
Figure 64. Assembly of First Leg

b. The tower assembly consists of nine pieces of structure: 3 legs, 2 tie beams, 1 main beam, and three braces, as shown in Figure 60. The tower is assembled by first joining the two tie beams, the main beam, and the three braces into the major triangle subassembly shown in Figure 61, using eighteen nuts and bolts. This triangular subassembly is then raised to a height of approximately 35-40 feet (Figure 62) so that a crane hook can be lowered through a corner to place a leg in position for attachment (Figure 63). The leg is then attached to the triangle using the 6 nuts and bolts provided (18 required total) as shown in Figure 64. This process is repeated for the remaining two legs (Figure 65) until the assembly is complete and the tower lowered onto the concrete footers where it is secured by four studs per leg. The final step in the tower assembly is to mount the upper head of the four-bar pendulum to the main beam (Figure 66) using the four nuts and bolts provided. The total on-site assembly time for this process is approximately four hours at a cost (professional steel riggers) of \$1845. To disassemble the tower assembly the above steps should be reversed.

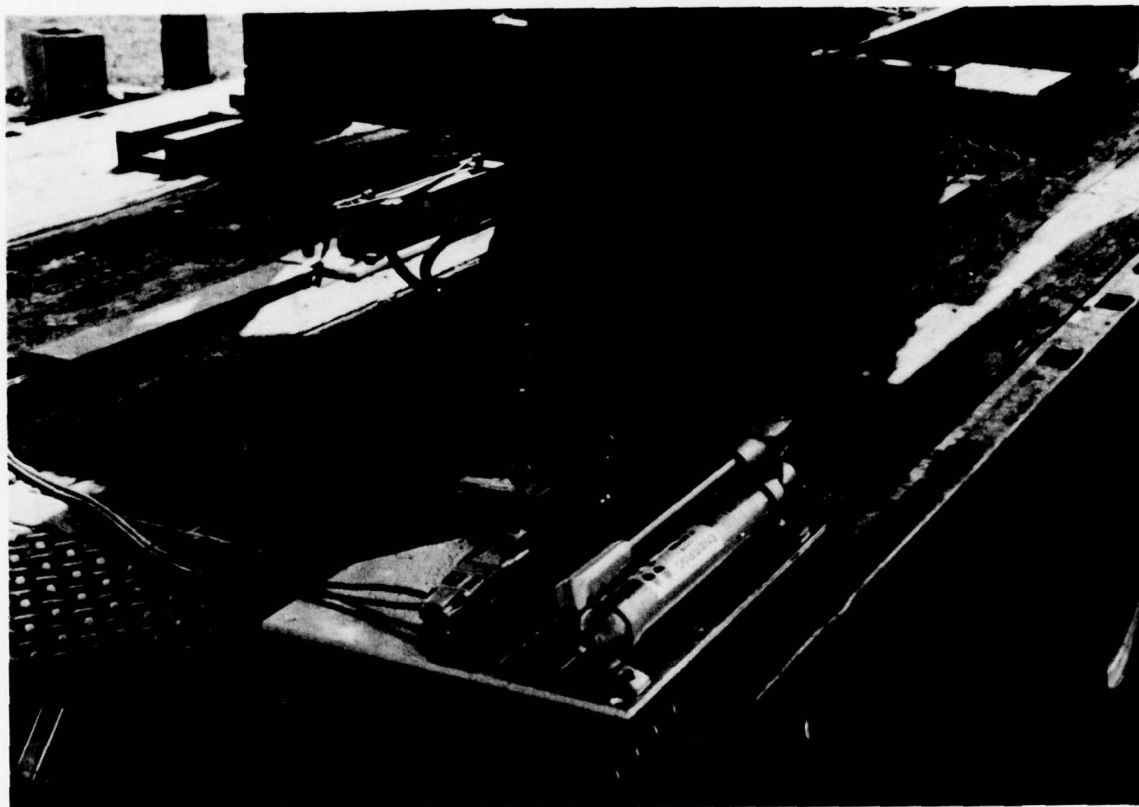
Figure 76. Hand Pump and Slide Block Detail

a. The vehicle cradle (Figure 75) is adjustable so that the approximate height required for pendulum mating may be obtained. The vehicle is secured to this "floating" portion of the cradle by means of three safety chains for the safe transport of the vehicle. This portion of the vehicle cradle is "floating" in that it rests on slide blocks controlled by a manual hydraulic pump and cylinder arrangement as shown in Figure 76. In this manner, the cradle provided the fine adjustments necessary in the X and Y axis to mate the vehicle with the pendulum head.

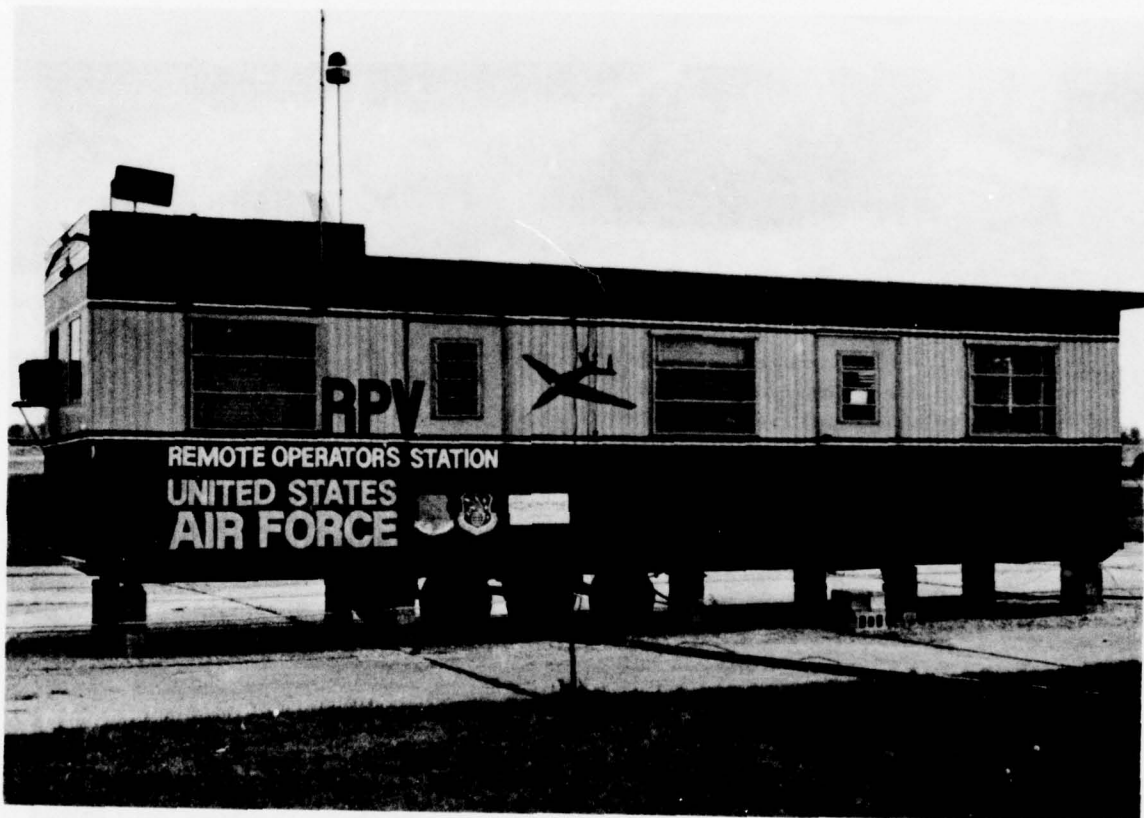
Figure 77. Instrumentation Trailer

A 10 foot x 40 foot house trailer was placed at the test site as a control station for the pendulum and as an instrumentation station. The trailer was furnished for use by the RPV SPO. The trailer (Figure 77) was equipped with a Test Controller Station which included a two way radio, public address system, warning lights, and the FIAS Control Board shown in Figure 78. Additionally, the trailer contained an instrumentation station for the recording of test data.

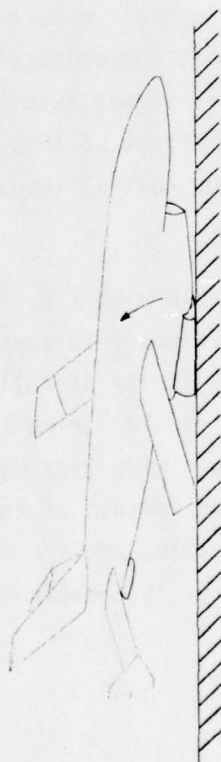
STEP 4: As the vehicle rotates it pivots back onto the bag recording an acceleration of 77 feet/sec<sup>2</sup>. As the vehicle continues to rotate about the wing tip and the bag the nose (due to the rotation) comes to a stop barely off the ground (all rate gyros record zero rotation at this point).

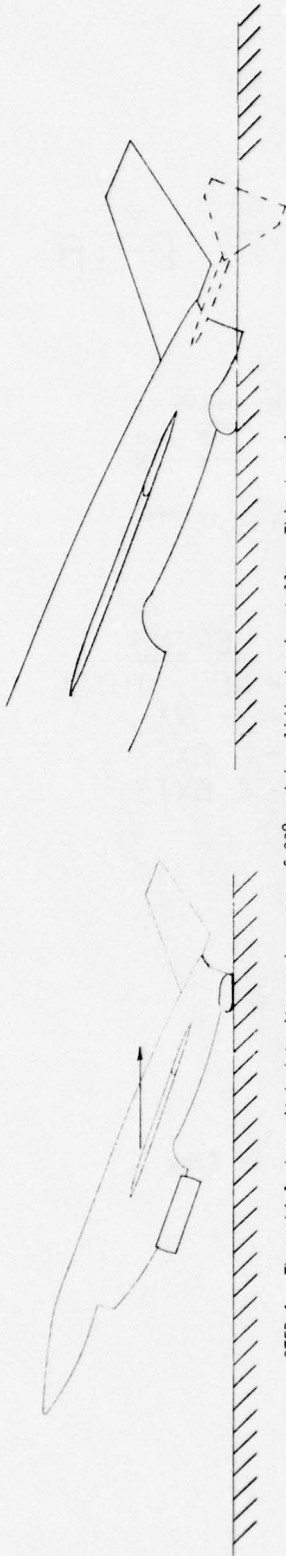
STEP 4: The vehicle has pitched to its maximum arc of  $20^\circ$  and is sliding horizontally. This dynamic balance is maintained for some time and is similar to a motorcycle "wheelie". During this slideout the tail bag rolls under the tail allowing the aft parachute can fitting to scoop dirt causing an X-axis acceleration of  $56 \text{ feet/sec}^2$ . This tail bag movement also allows the horizontal stabilizer to contact the ground and break off.

b. The vehicle dynamics during a  $180^\circ$  yaw (tail first) 15 knot drift landing are shown in Figure 95. This maneuver has been descriptively dubbed the "wheelie" because it involves a dynamic balance similar to a motorcycle wheelie during the slideout portion.
